DYNAMIC SEALS FOR ADVANCED HYDRAULIC SYSTEMS

Robert B. Olsen
Vought Corporation
P.O. Box 225907
Dallas, Texas 75265

August 1981

Final Report for Period July 1978 - March 1981

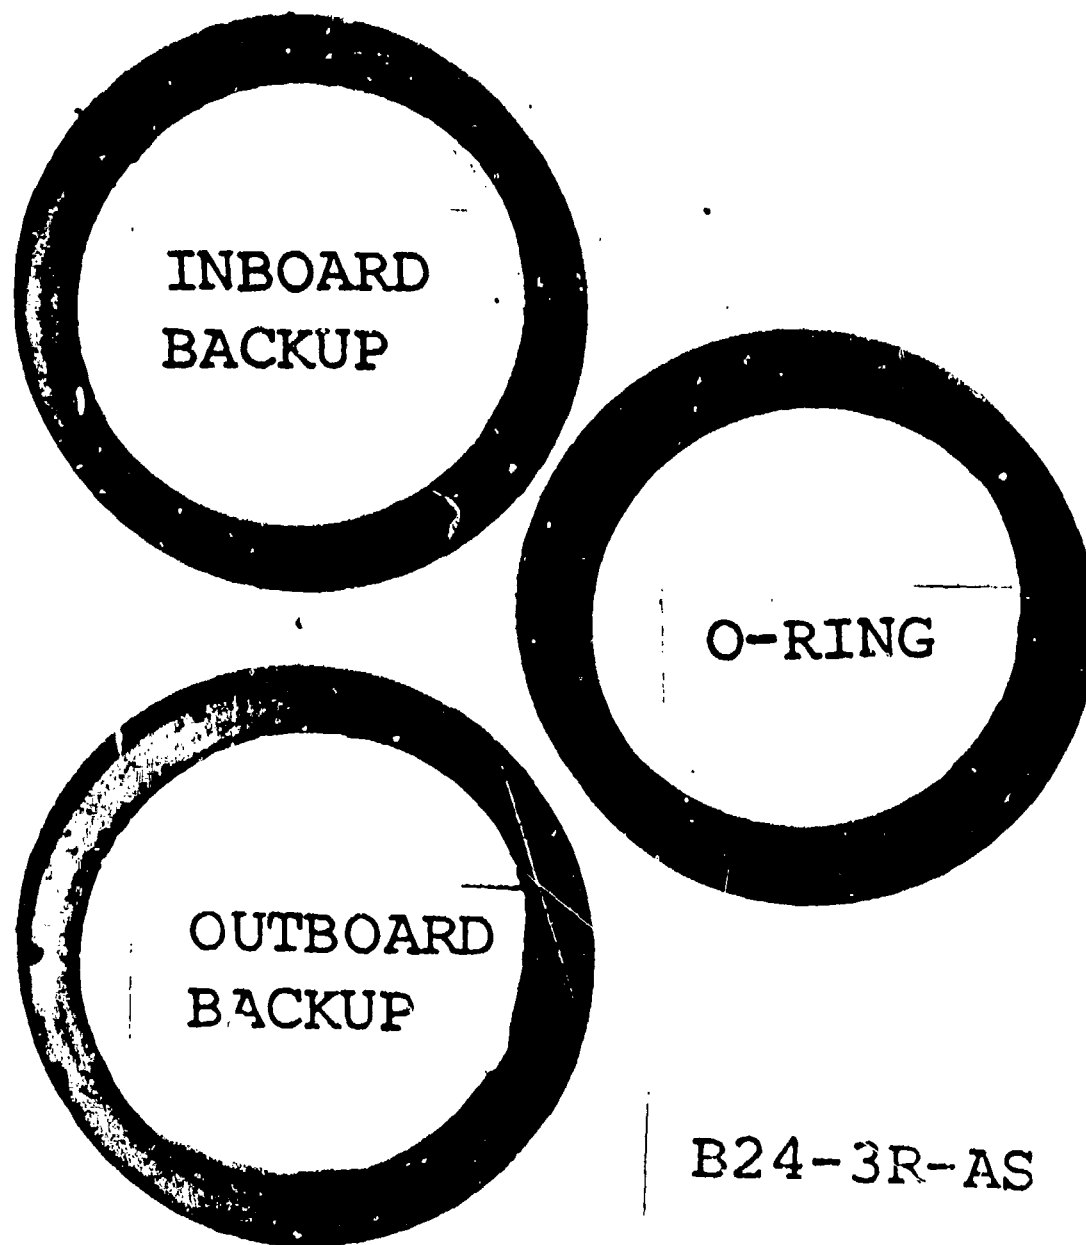
Figure 59. Candidate B23 Backup After Additional Screening Test.
U-ring condition is excellent.

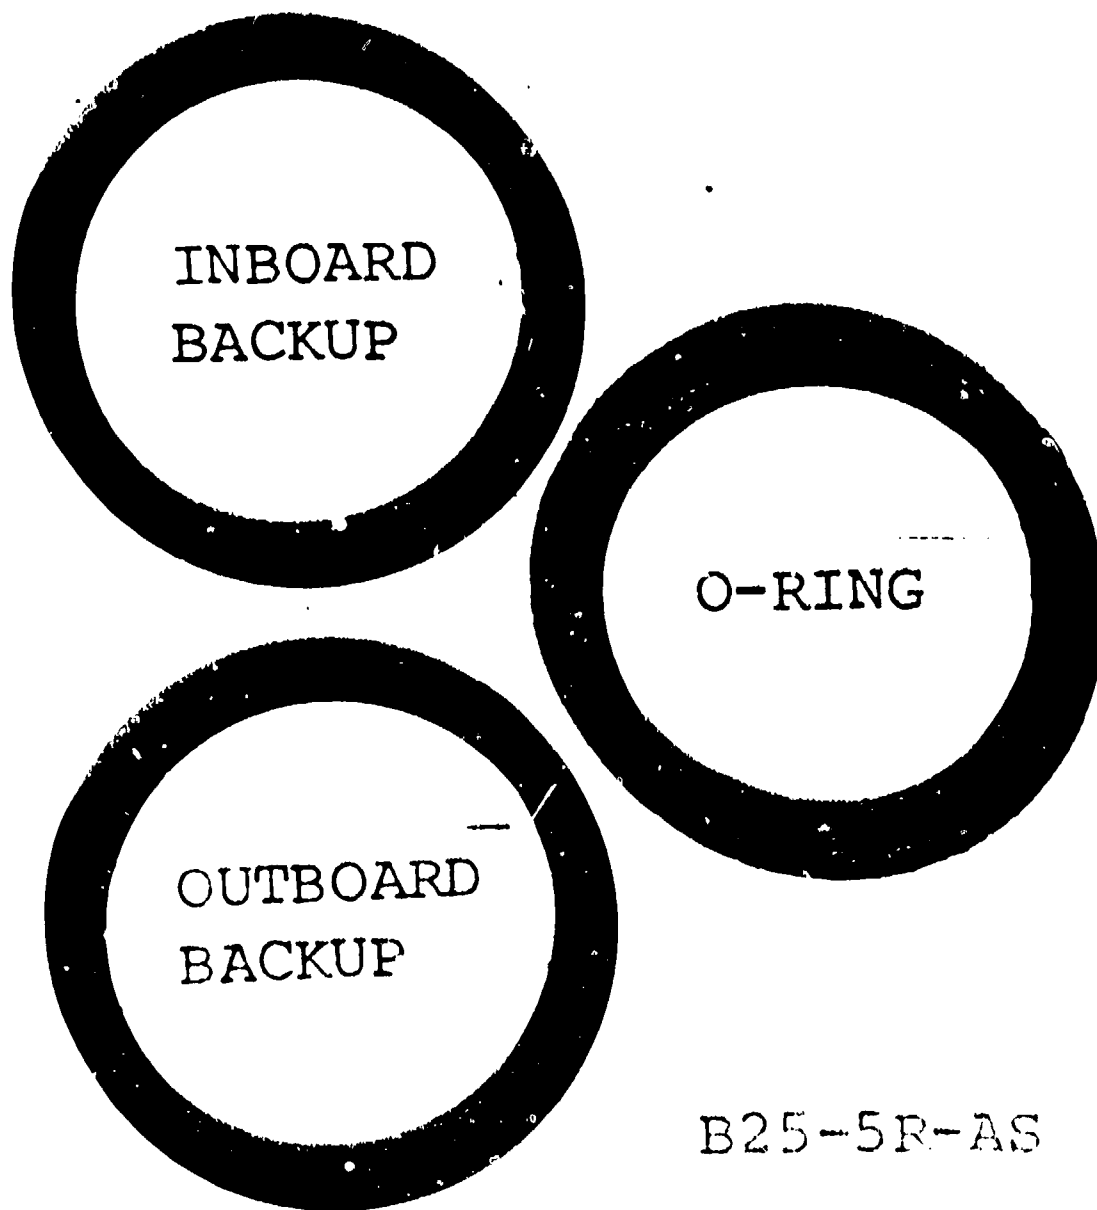
Figure 60. Candidate B24 Backup After Additional Screening Test.
O-ring condition is good. Zero leakage was recorded.

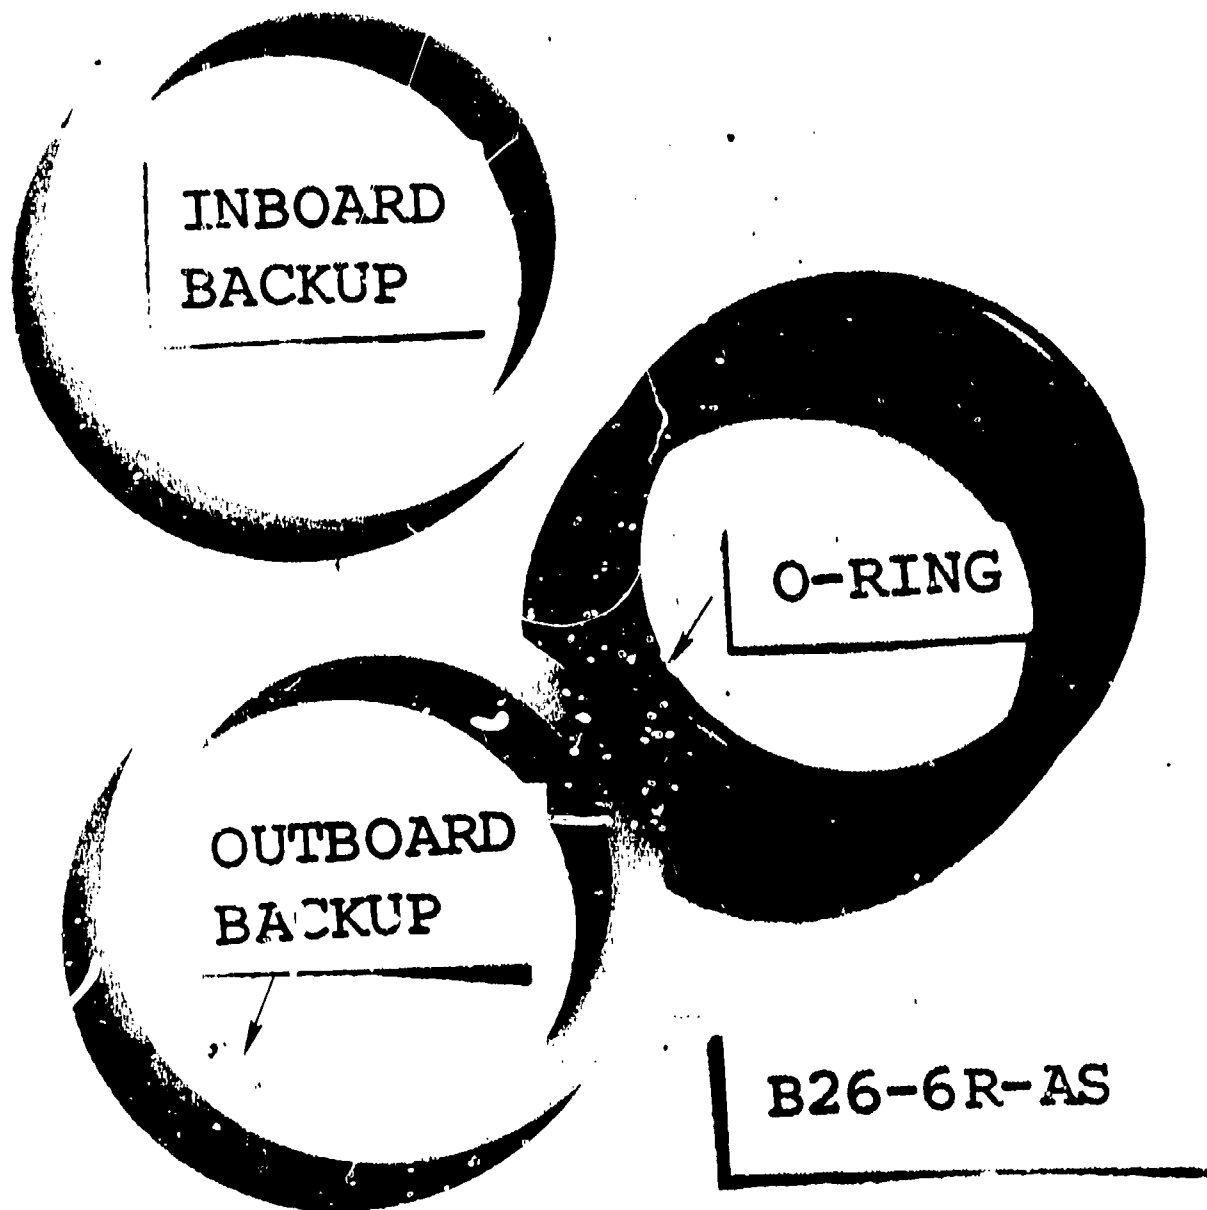
Figure 61. Candidate B25 Backup After Additional Screening Test.
O-ring is severely nibbled and has rolled.

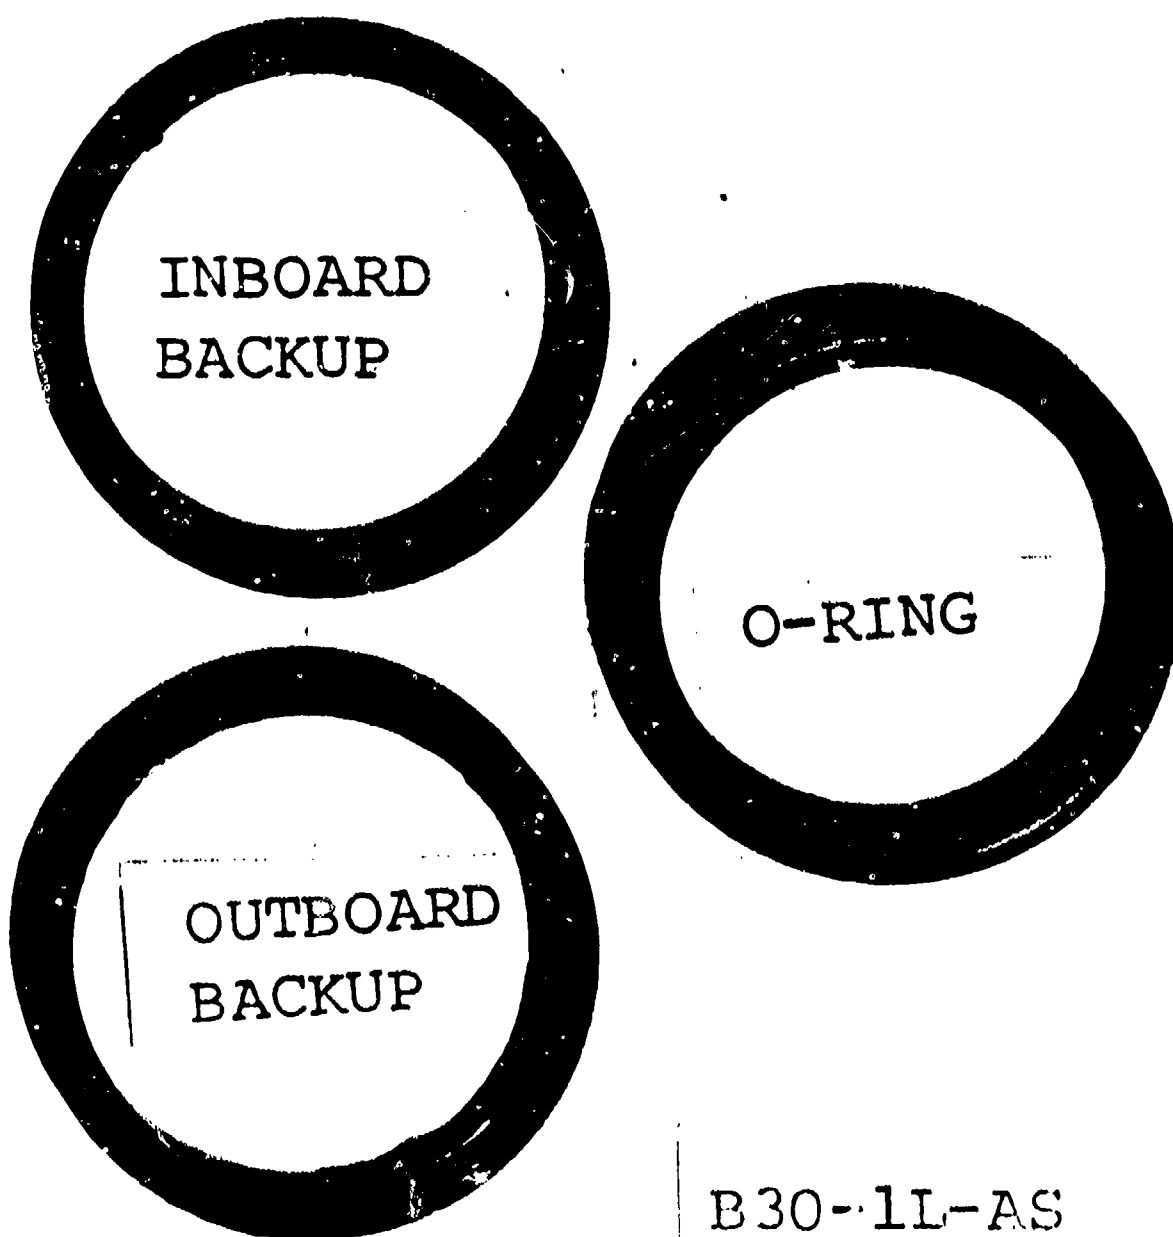
Figure 65. Candidate B29 Backup After Additional Screening Test.
O-ring is in good condition.

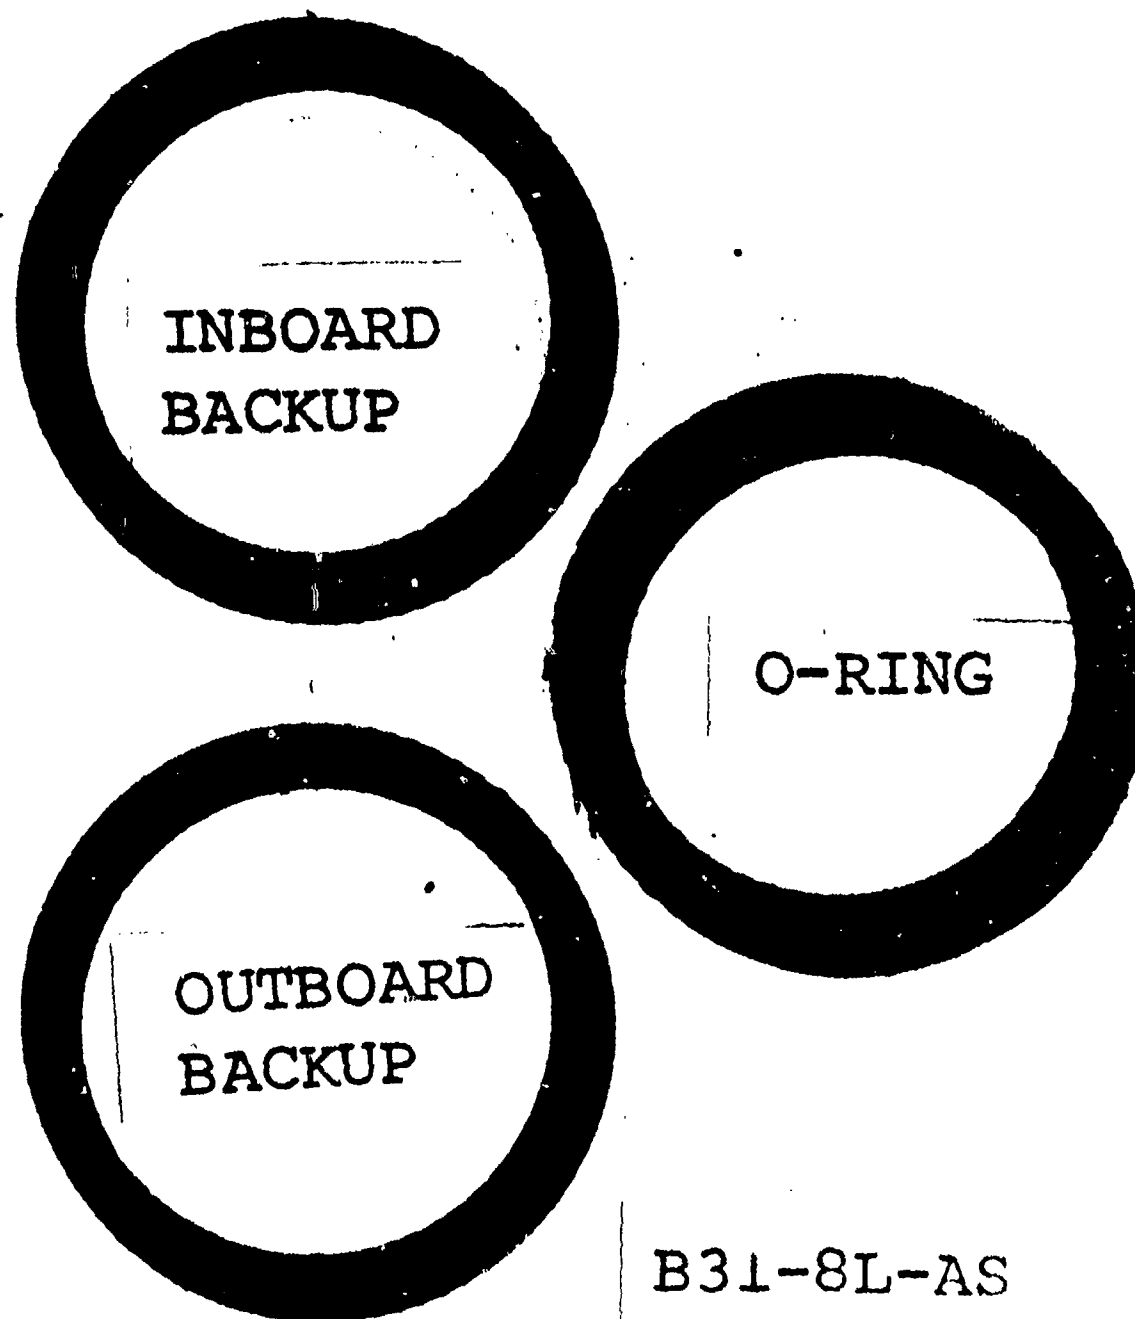
Figure 66. Candidate B30 Backup After Additional Screening Test. O-ring is in excellent condition.

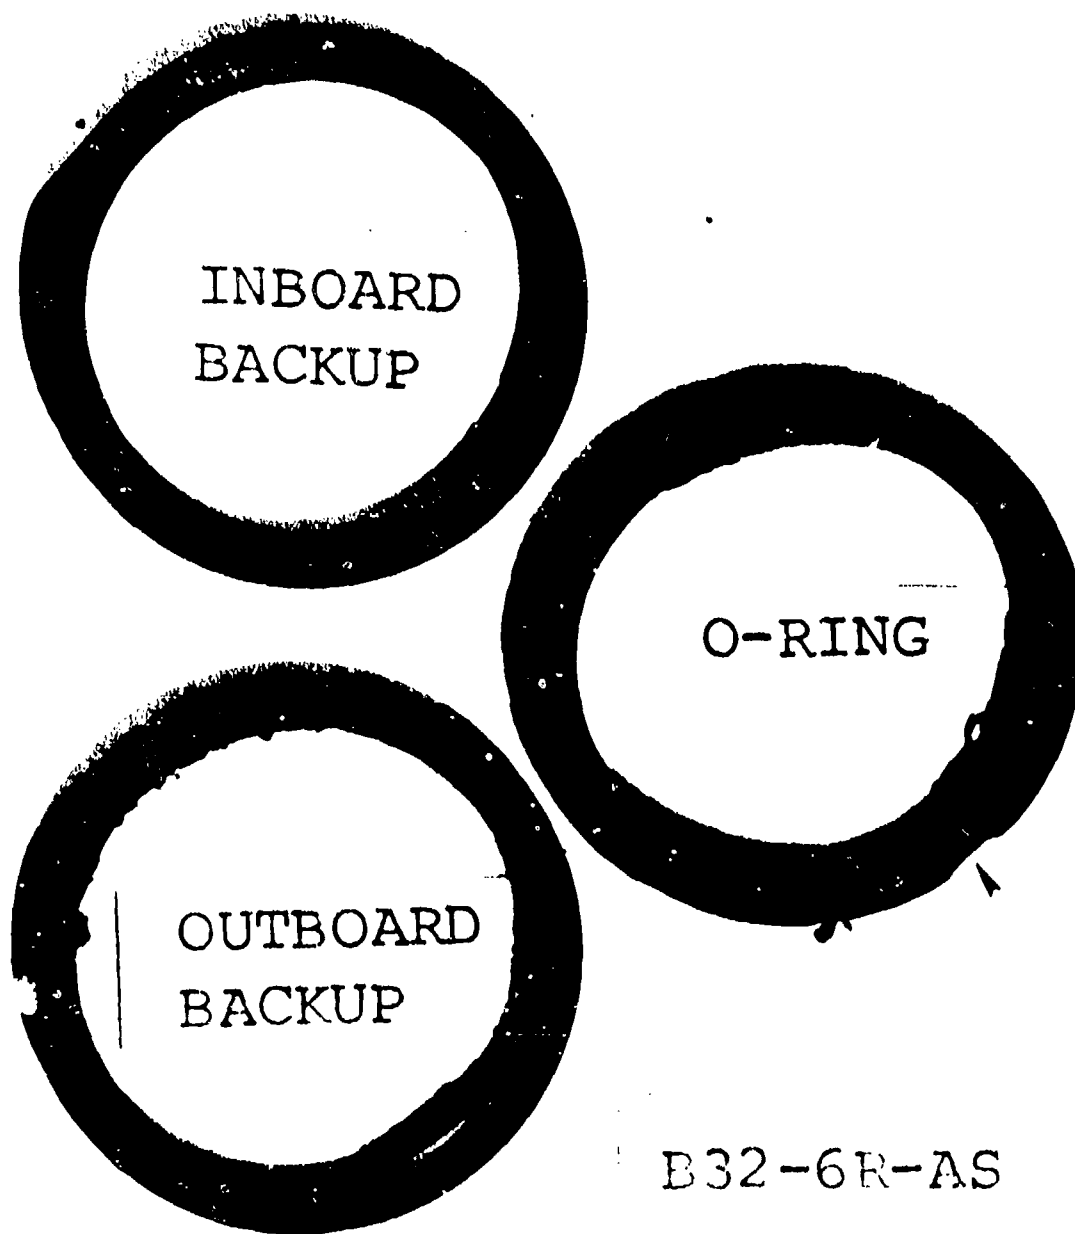
Figure 67. Candidate B31 Backup After Additional Screening Test.
Seal finished test but failed due to leakage.

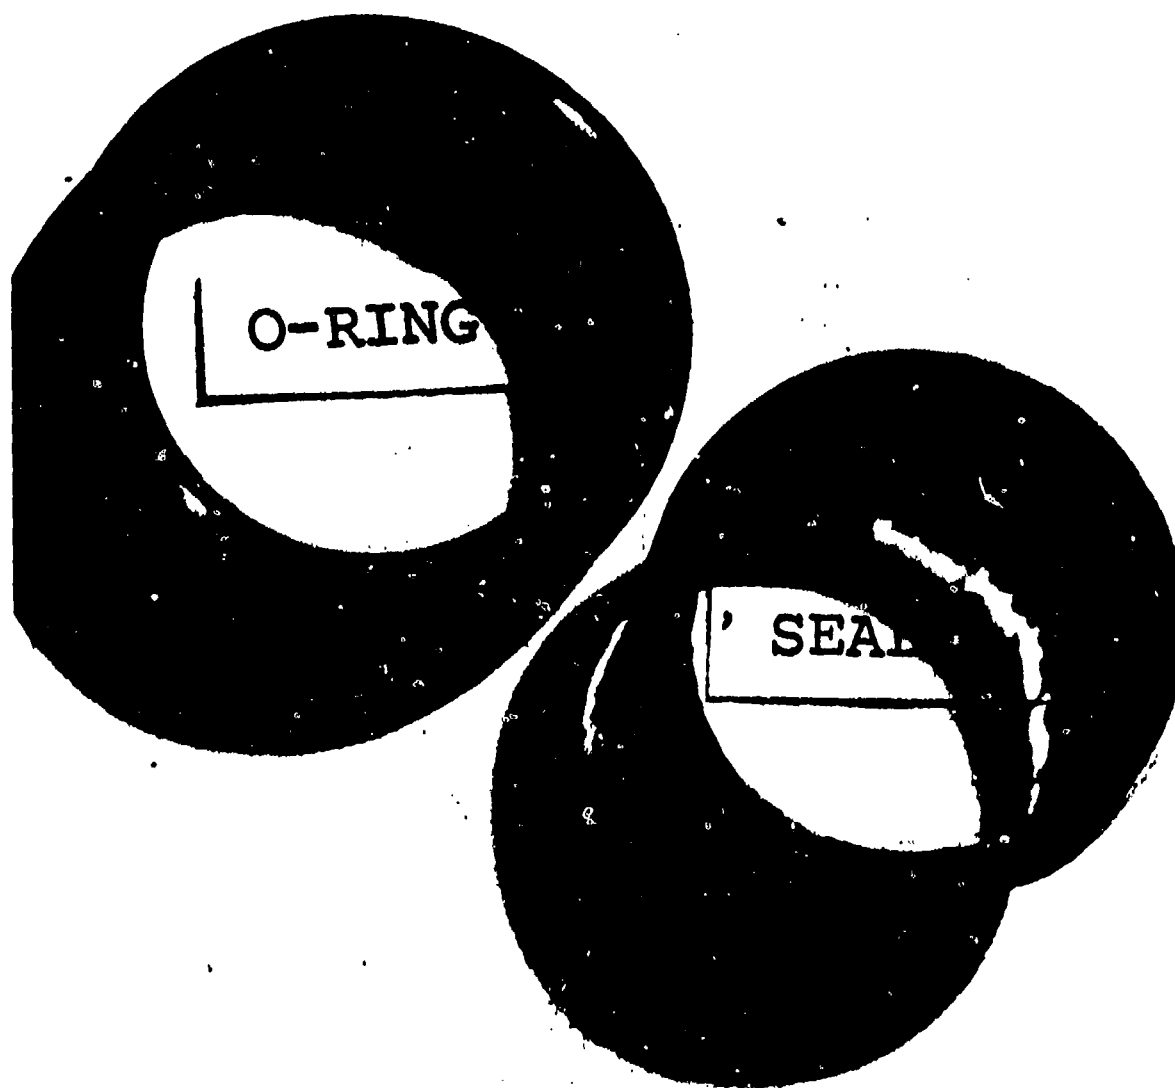
Figure 145. Candidate TRS18-UV (2nd Stage) After Two Stage Rod Seal Screening Test. Two stage installation had no external leakage.

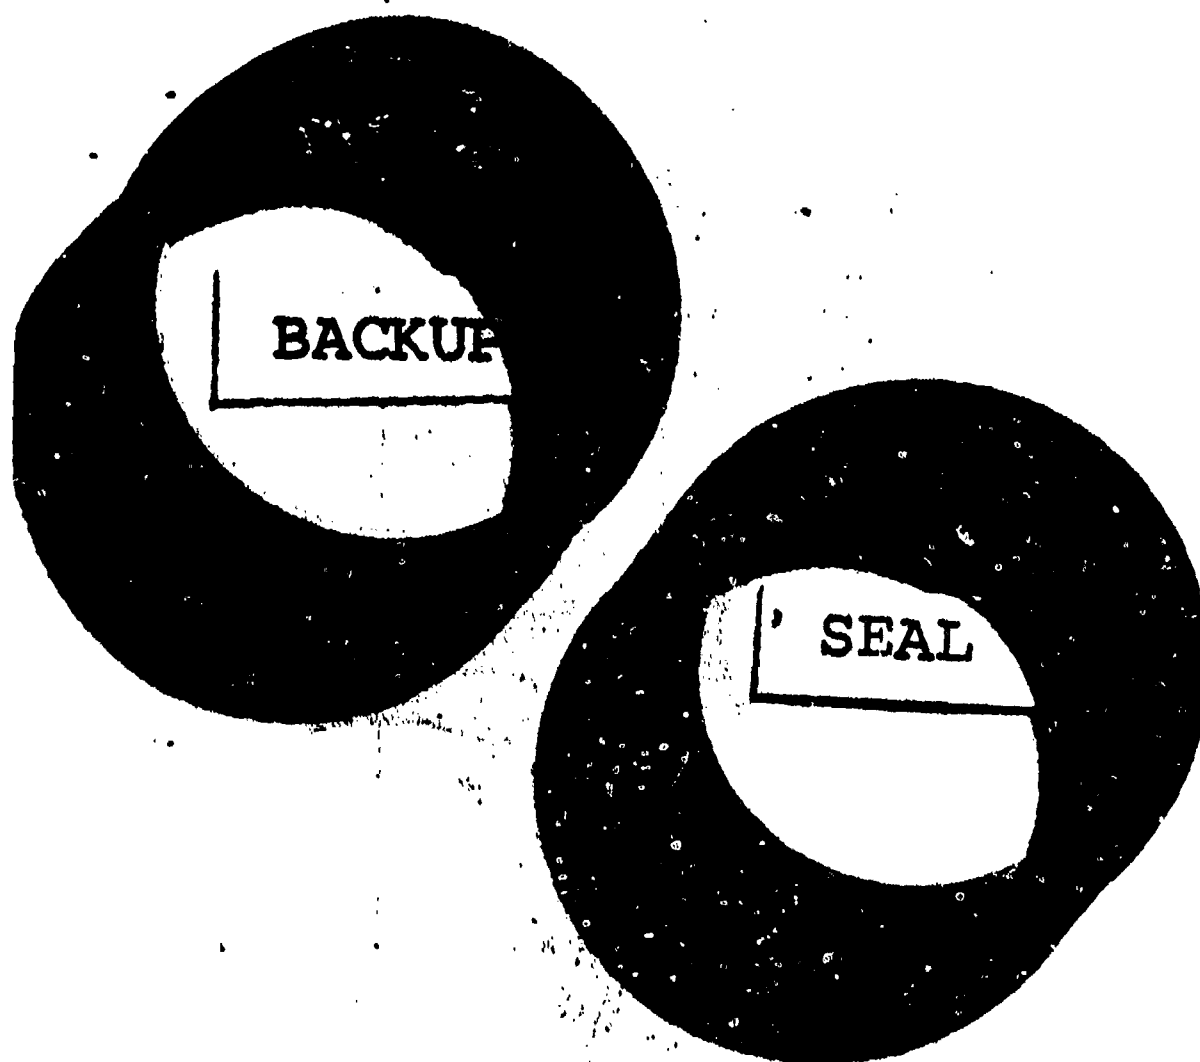
TRS19-V-6R-TR
1ST STAGE

Figure 146. Candidate TRS19-V (1st Stage) After Two Stage Rod Seal Screening Test. Seal used -318 size O-ring to energize cap strip. This seal was worn through during test.

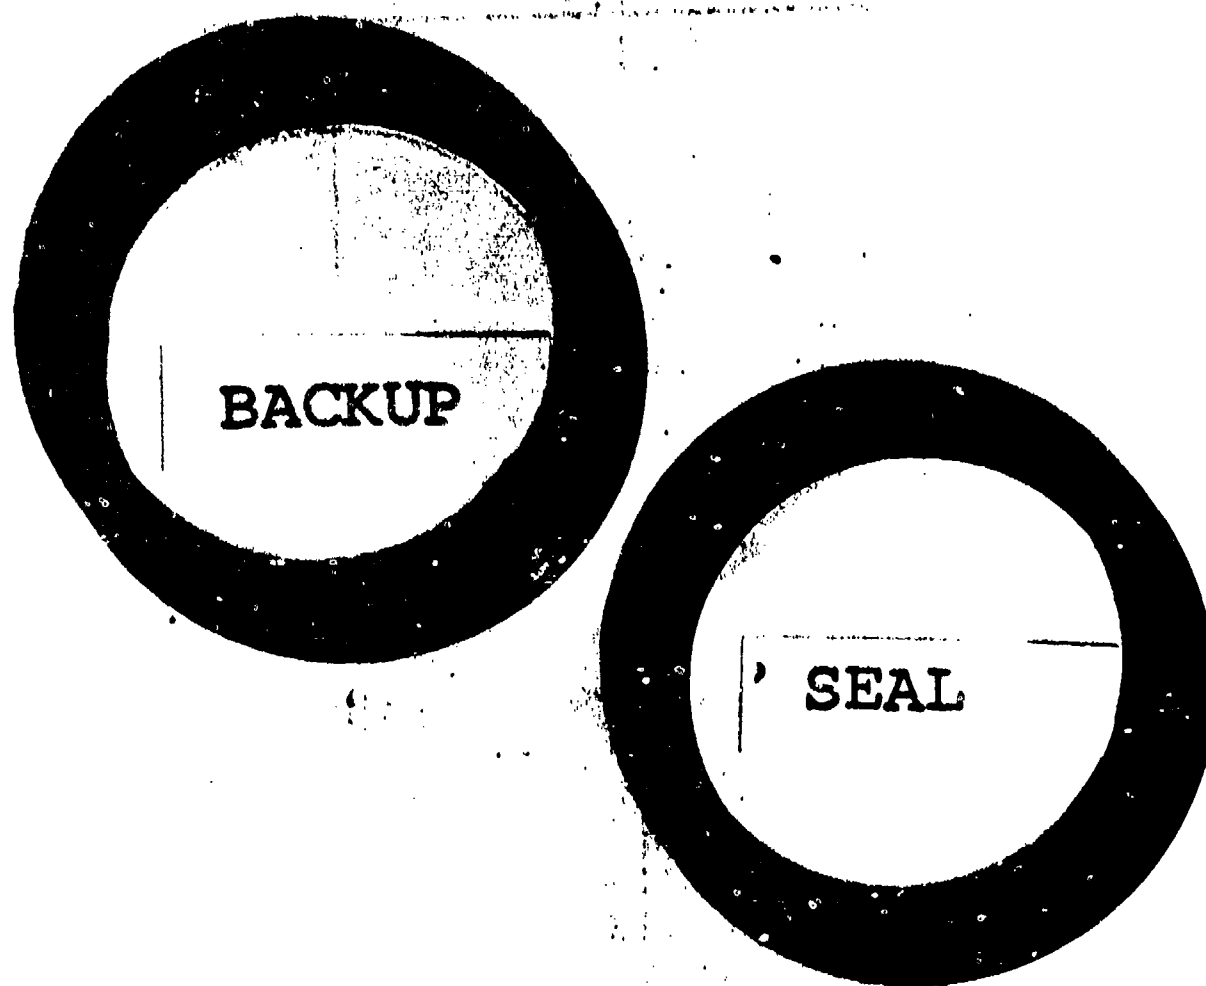
TRS19-V-6R-TR
1ST STAGE

Figure 148. Another view of TRS19-V (1st Stage). Arrows show extent of seal damage.

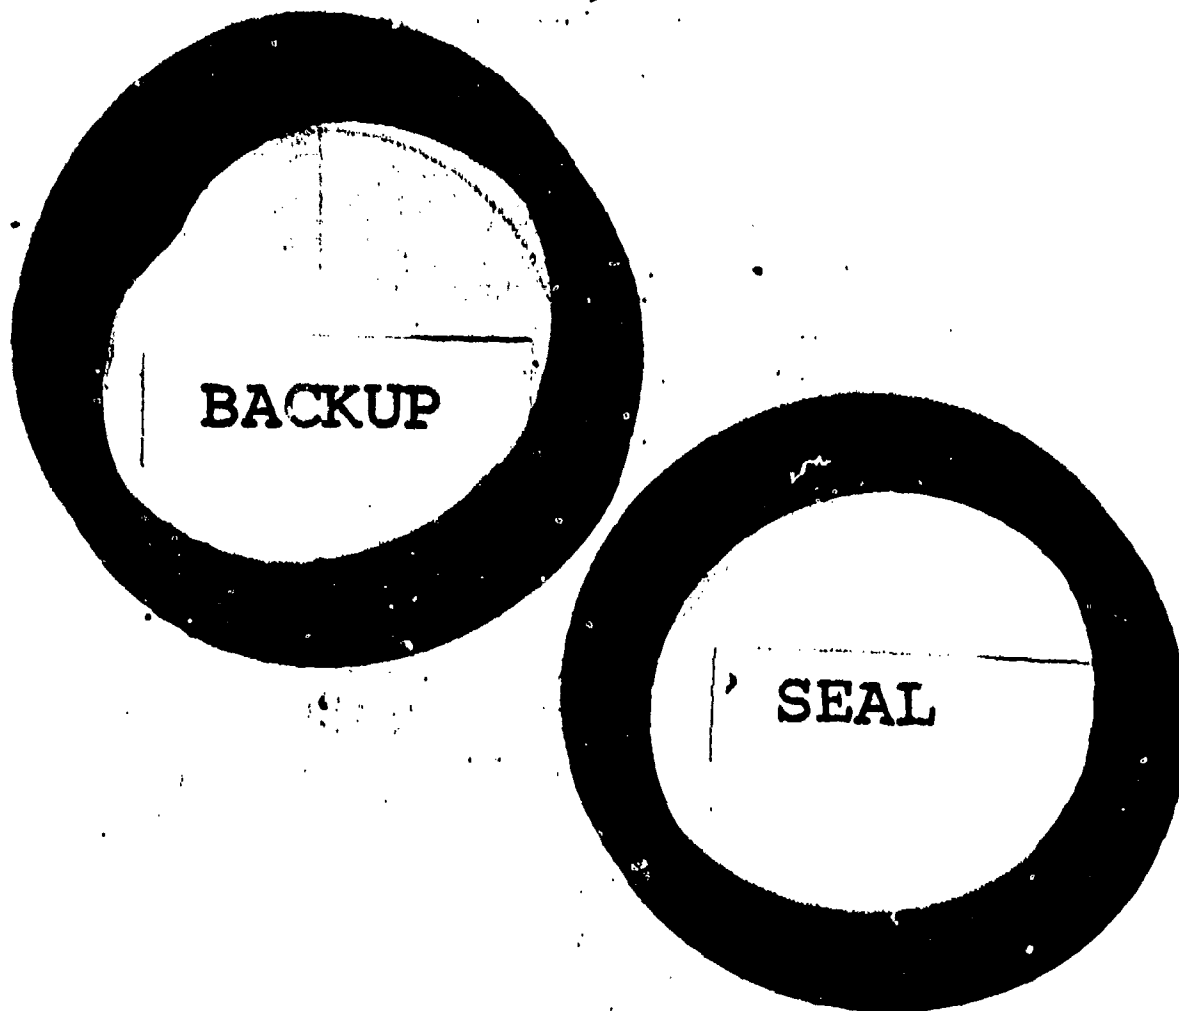
TRS20-UV-9R-TR
1ST STAGE

Figure 149. Candidate TRS20-UV (1st Stage) After Two Stage Rod Seal Screening Test. Seal was in excellent condition after test.

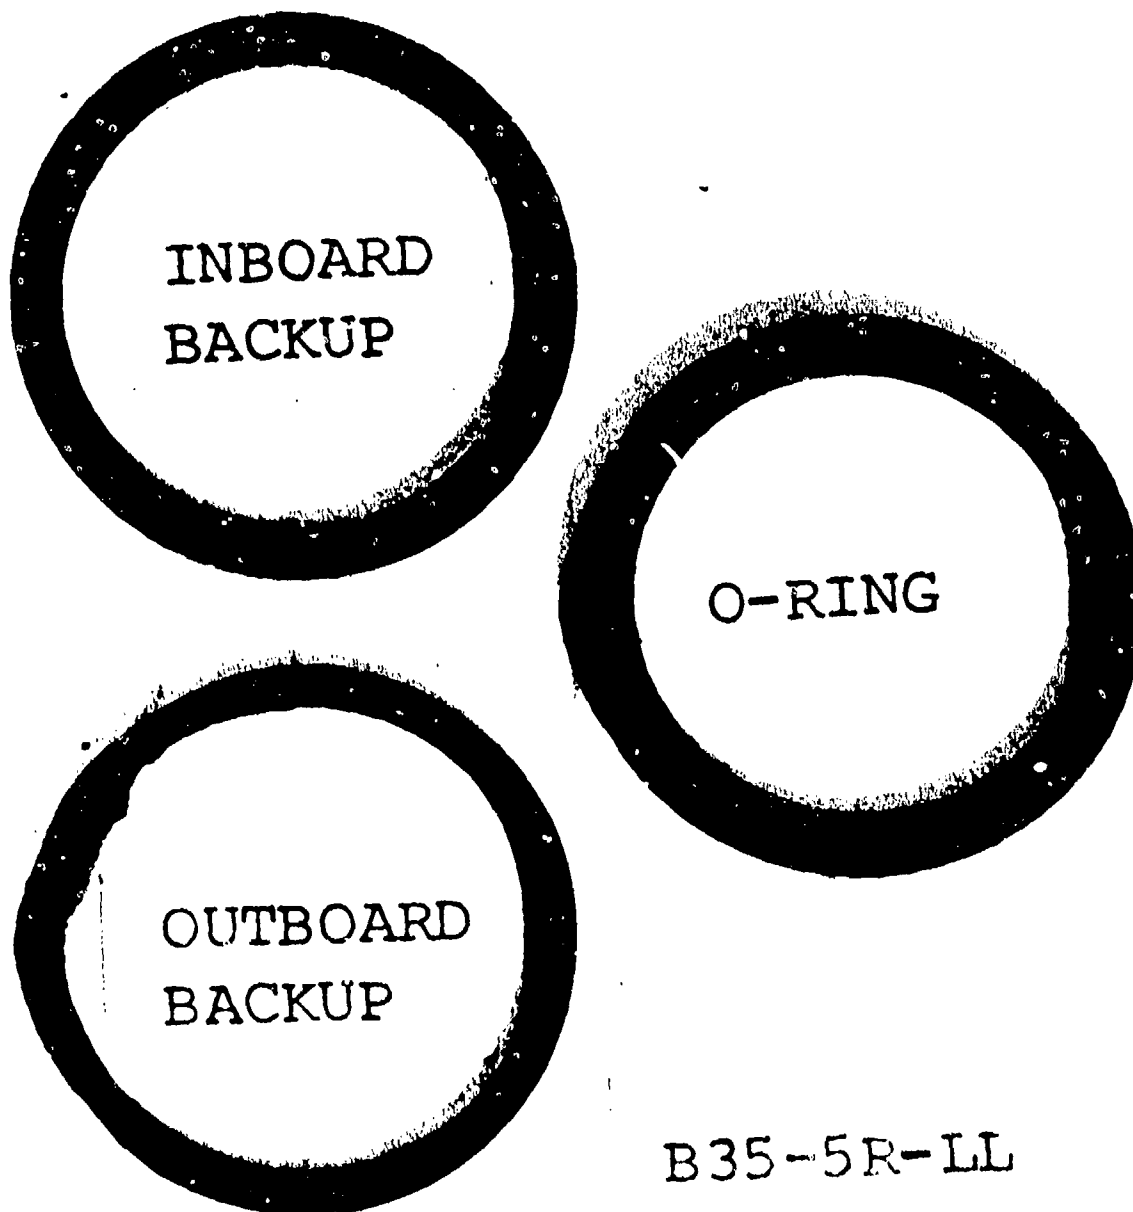
Figure 156. Candidate B35 After Long Life Test. O-ring is in excellent condition after 13.31×10^6 endurance cycles.

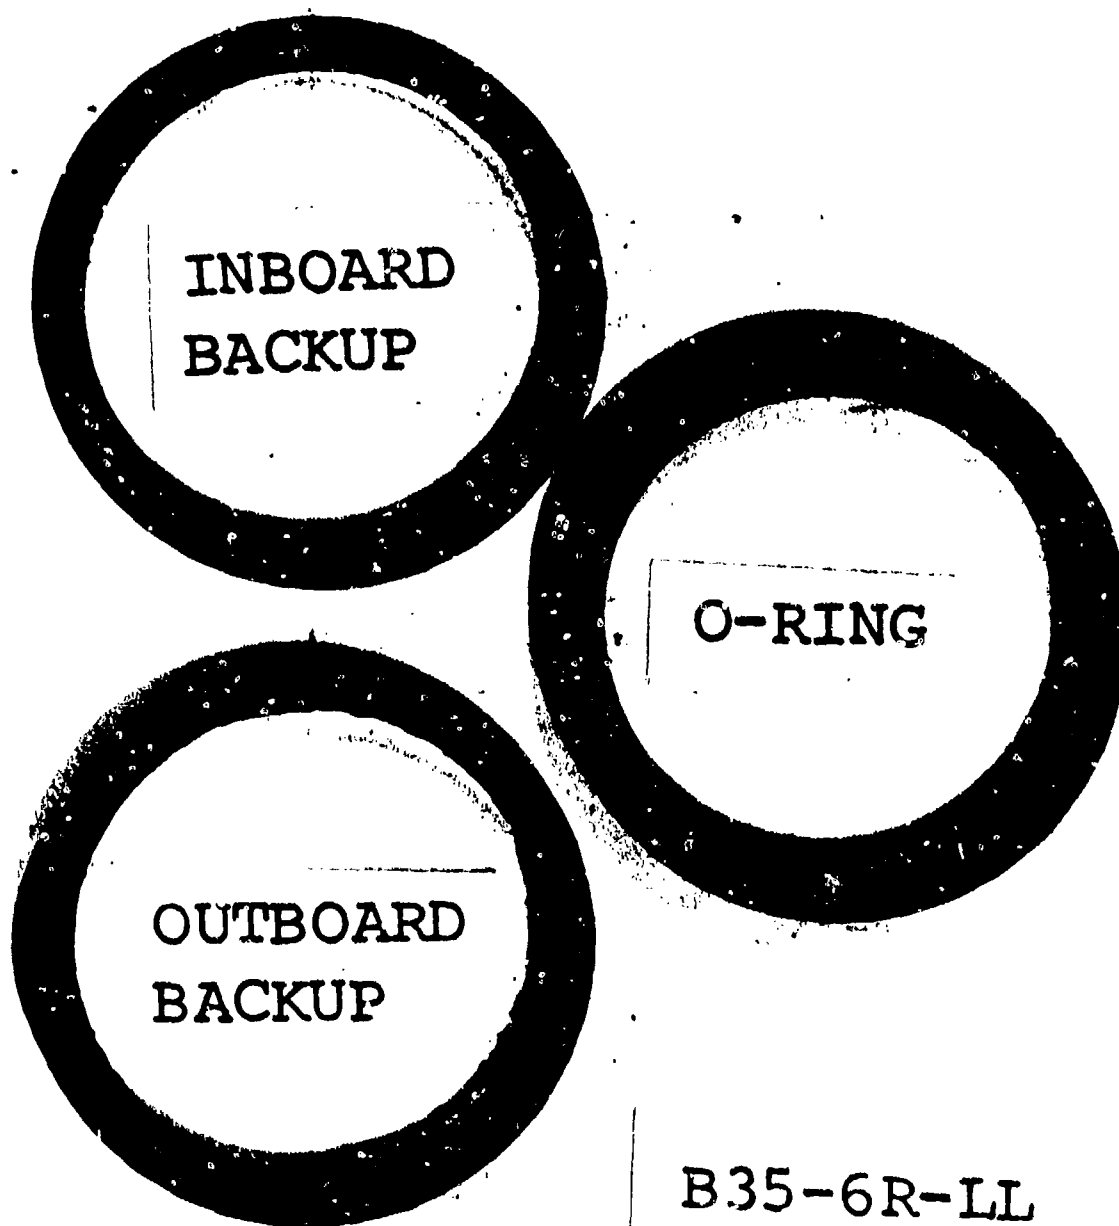
Figure 157. Candidate B35 After Long Life Test - Aluminum Bronze End Cap Installation. O-ring is in good condition. The outboard backup ID was loose fit on rod after tests.

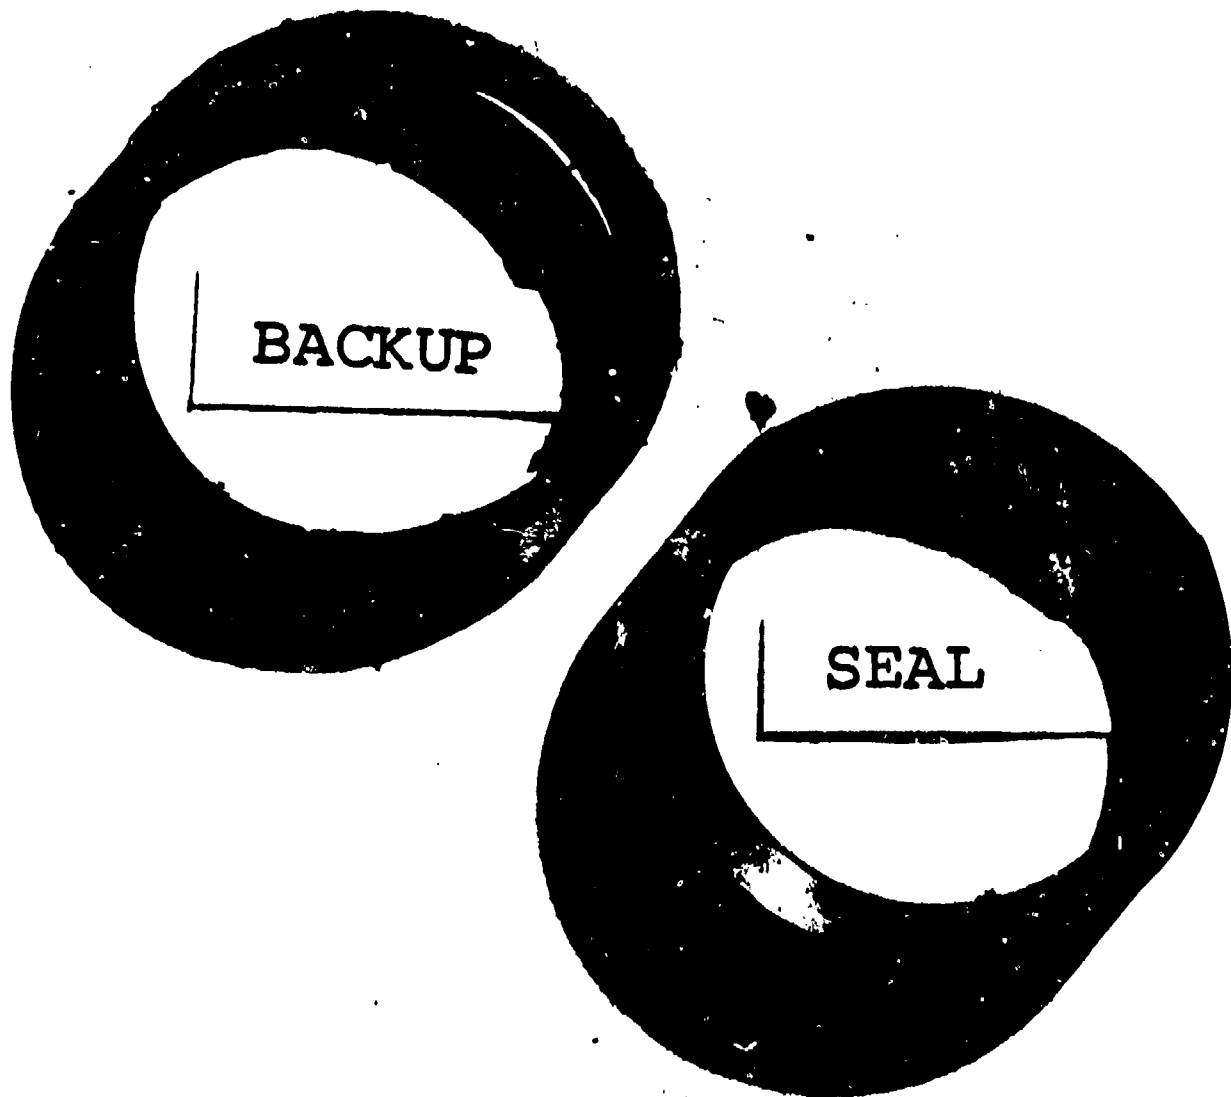
TRS4-UV-8R-LL
1ST STAGE

Figure 160. Candidate TRS4-UV (1st Stage) After Long Life Test. The backup cross section has worn approximately 25 percent and the ID is greater than 1.005 inch.
